Inspection and Assembly of a Power Solutions 6-1 Lister-Type Diesel Kit Engine Part II

July 22, 2006

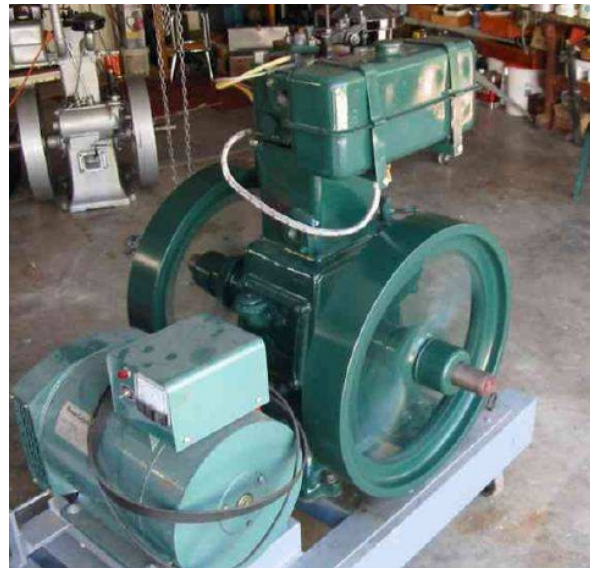
Here's the proof. I removed my other engine from its generator bed and bolted down the test engine. After filling the crankcase with oil and evicting the air bubbles from the fuel lines and filter, I engaged the starting handle and gave it a whirl. I closed the decompressor and the engine chugged to life. The governor linkage was initially set too high and I had to close the fuel rack by hand. Best to warn customers to start the engine with a hand on the linkage, then turn the adjusting screw until the desired speed is reached.

The engine settled down to a smooth and steady beat. No different in action or sound from my Ashwamegh. Tappets rotate about ½ turn each time they lift, the governor seems to be working well, and there are no fuel leaks. Even the petcock on the bottom of the tank does not leak a drop. And the engine seemed to be well balanced. My Ashwamegh is a very smooth running engine, and this one is no rougher, and possibly a little smoother.

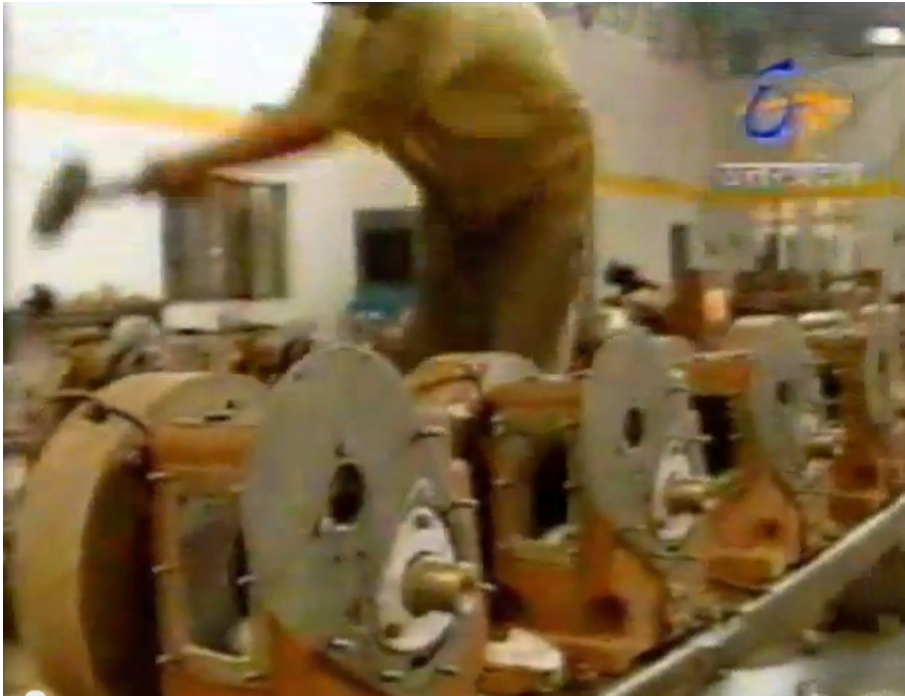
The video showed many practices that were horrific to our Western sensibilities, but none more so than that of a worker swinging a large sledge hammer to set the gib keys. While I was unable to locate that video, at left is a screenshot I took from an

Indian video that is currently on YouTube which shows a worker swinging a sledge hammer to set the gib key in what appears to be a Petter clone engine. The worker, by using a sledge hammer, manages to deform the key and the keyways sufficiently to lock the flywheel to the crankshaft. However, by properly fitting the key, a few taps with a small hammer should achieve the same result, without risking damage to the tapered roller bearings, the crankshaft, and the flywheel hub.

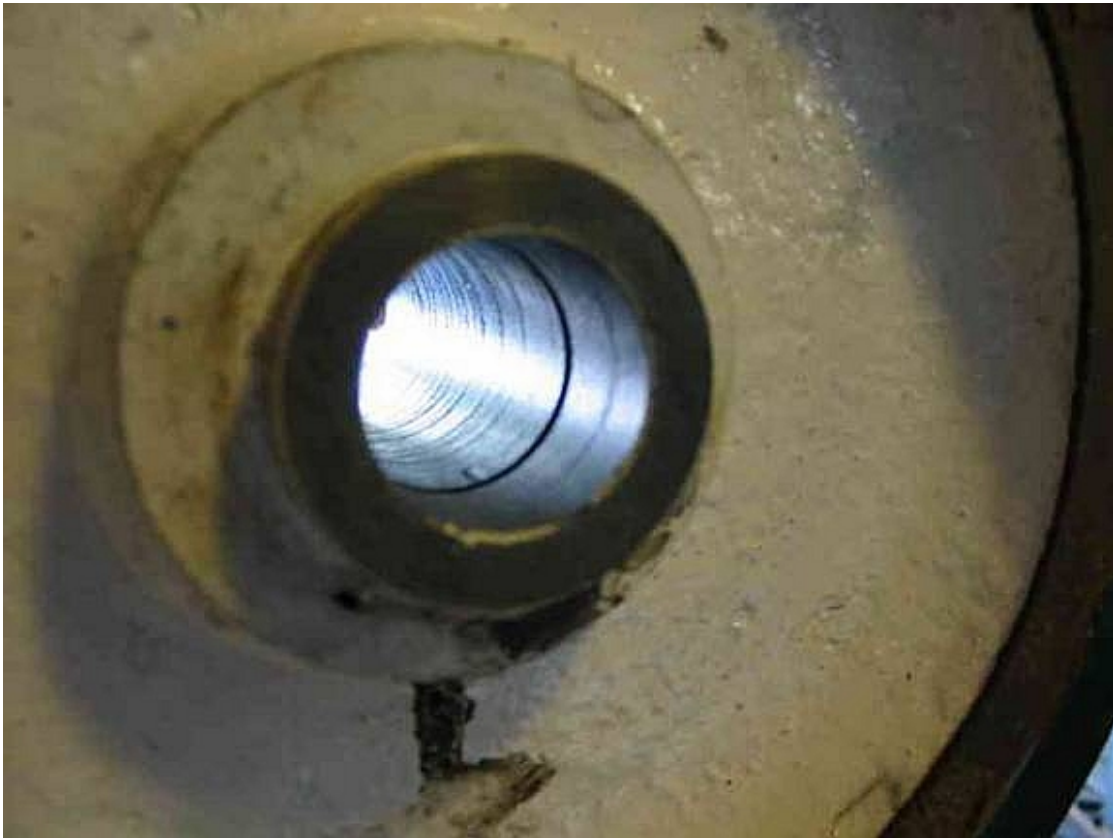
I disconnected the linkage between the governor and the injection pump on the other side of the engine and removed the camshaft after first removing the tappets and guides. Below is a close-up of the steel camshaft end bushing.

Looking inside I discovered a very small amount of dirt, but more bothersome to me was the poor finish of this bushing. There are rough spiral marks in the bore that look like what you'd get if you drilled a deep hole with a twist bit without periodically withdrawing the bit and blowing out the chips. It looked like the bushing had not been finished with a ream, or even on a lathe with a boring bar. However the bushing had a nicely finished shoulder on the outboard end that was where the camshaft rode. I applied some Prussian Blue and found that the poorly finished section of the bushing did

not contact the camshaft. The camshaft showed no wear marks after ½ hour of total run time. The bushing measures 3.005" long, 0.880" inside diameter and 1.375" outside diameter. The camshaft is 0.875" diameter, so the clearance is 0.005" a decent slurp fit.

It would be simple to make a puller for the bushing with a piece of threaded rod, a 2" pipe nipple and a couple of nuts and washers, and I've given some thought to replacing the bushing with an oil-impregnated bronze bushing. But that might be polishing the fruit at the bottom of the bowl. A hardened steel camshaft turning only 325 rpm, riding in a lubricated steel bushing should last almost forever so long as it gets lubricated, and I had some ideas about how to enhance oil flow to the bushing.

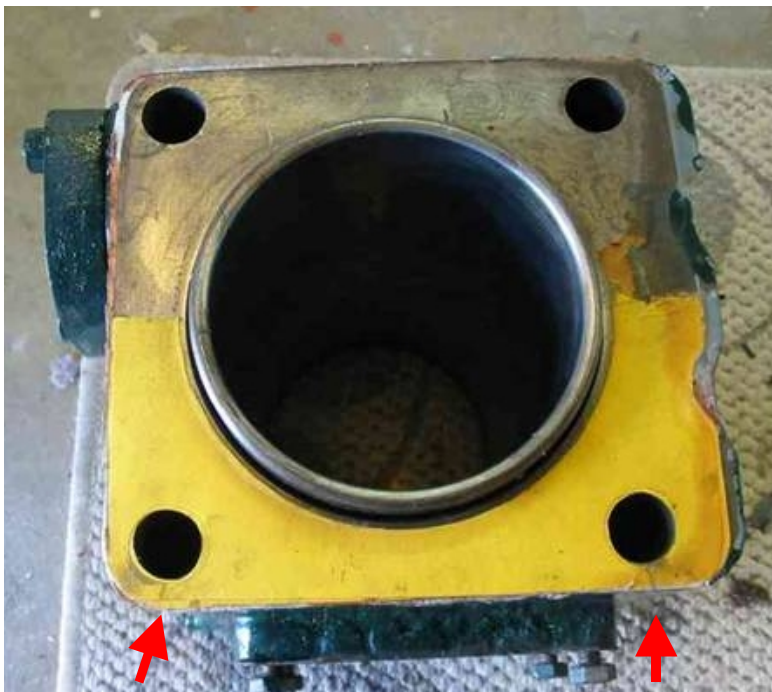
Next, I rotated the crankshaft until the piston was at BDC and lifted the cylinder off the piston. I removed a few paper base gaskets and then found this:

What the heck could that be? One 0.0075" thick half gasket had been stacked as a shim on the starting-flywheel side. Note the tears in the shim for the stud holes (red arrows). That indicates the shims were placed beneath the cylinder after the cylinder had been placed on the crankcase. I had been alerted to the existence of the yellow half-shims by Jack Belk, and John Ferguson e-mailed me that he had

seen them, too. At the time nobody knew for sure what the gaskets were for, but it appeared that somebody in Rajkot evidently thought the cylinder casting or the cylinder sleeve was not square and shimmed up one side 0.0075". That's cause for worry because if the cylinder is not square to the travel of the piston, it might scuff against the liner at the bottom and/or top of its travel, or excessive side loading might prematurely wear the wrist pin bushing and/or rod bearing. I took the cylinder to a friend's machine shop and placed it on a ground slab of steel and using a height gauge determined the cylinder base and head surfaces were parallel to each other without any shims. However that doesn't mean that the cylinder sleeve was perpendicular to the base.

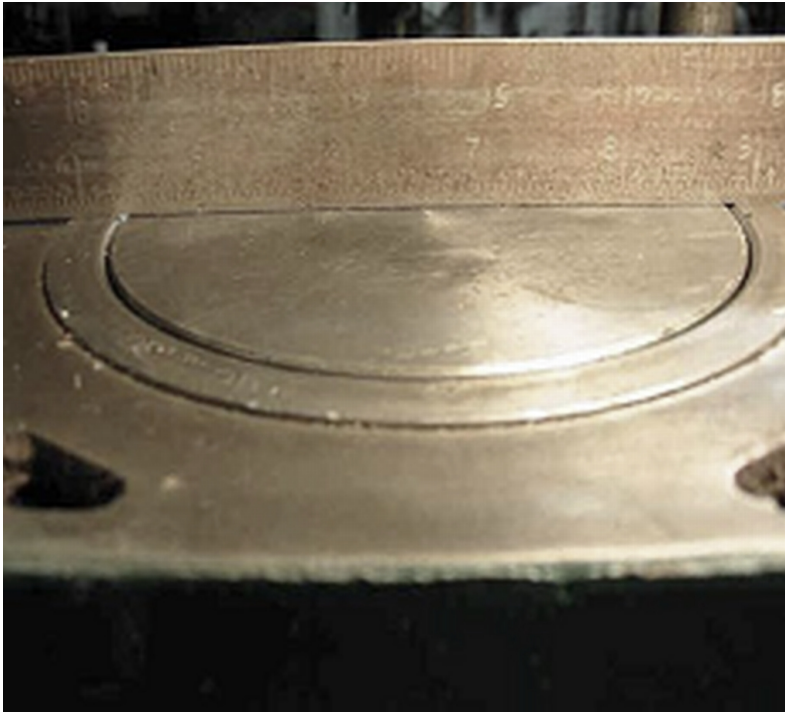
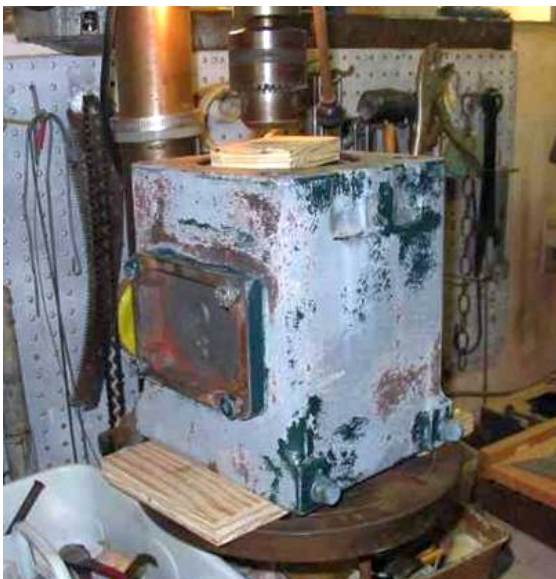
Next, I replaced the piston with rings into the cylinder and lowered the cylinder onto the crankcase WITHOUT any base gasket or shims. Metal to metal. I also remounted the crankshaft in the TRBs and torqued everything to spec. Because the shim gaskets were absent, at TDC the piston projected slightly above the rim of the sleeve.

I balanced a straightedge on the top of the piston. I slowly rotated the crankshaft until the piston receded inside the cylinder, leaving the straightedge balanced on the liner with a sliver of light gleaming between the piston top and the bottom of the straightedge. The sliver of light was even, side to side. Had the piston been out of square with the cylinder casting, by even a couple of thousandths, it would have been visible. And if

the cylinder liner had been out, I would have seen that too. So the piston is square to the cylinder, the cylinder base is parallel to the top. So how come the Indian assembler thought he needed to shim up one side of the cylinder by 0.0075"?

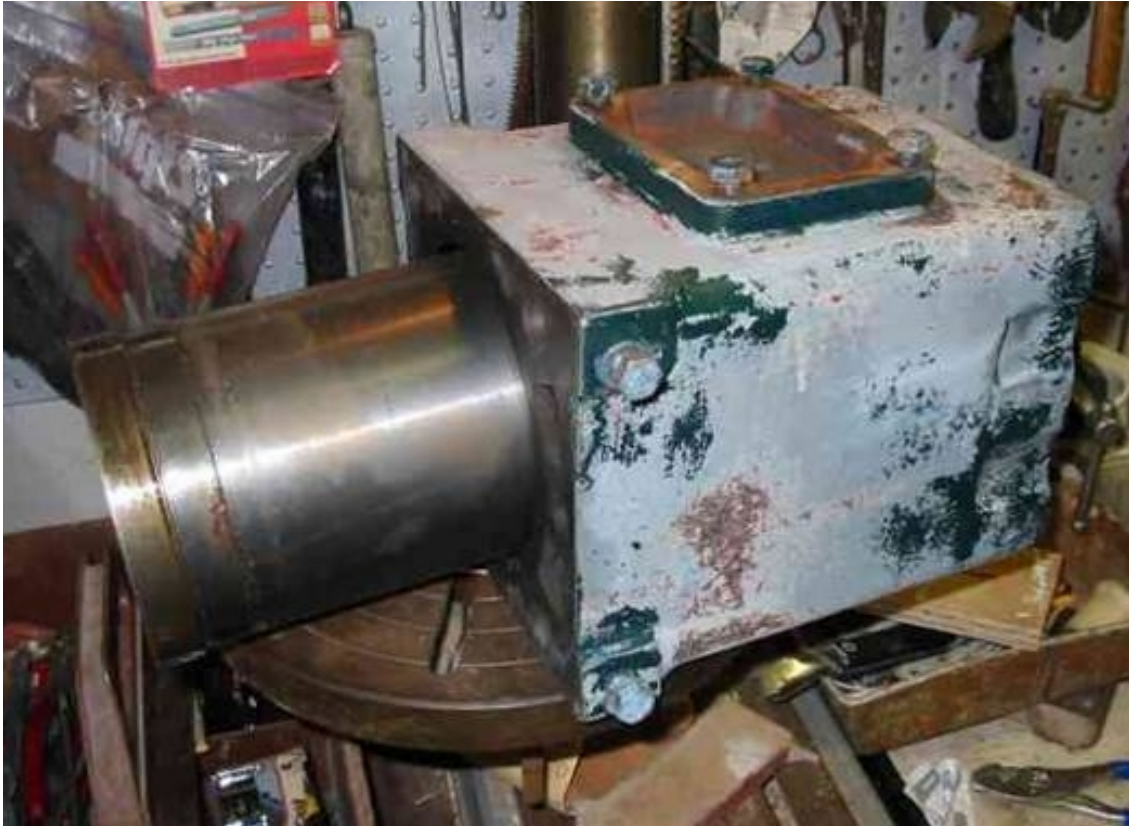
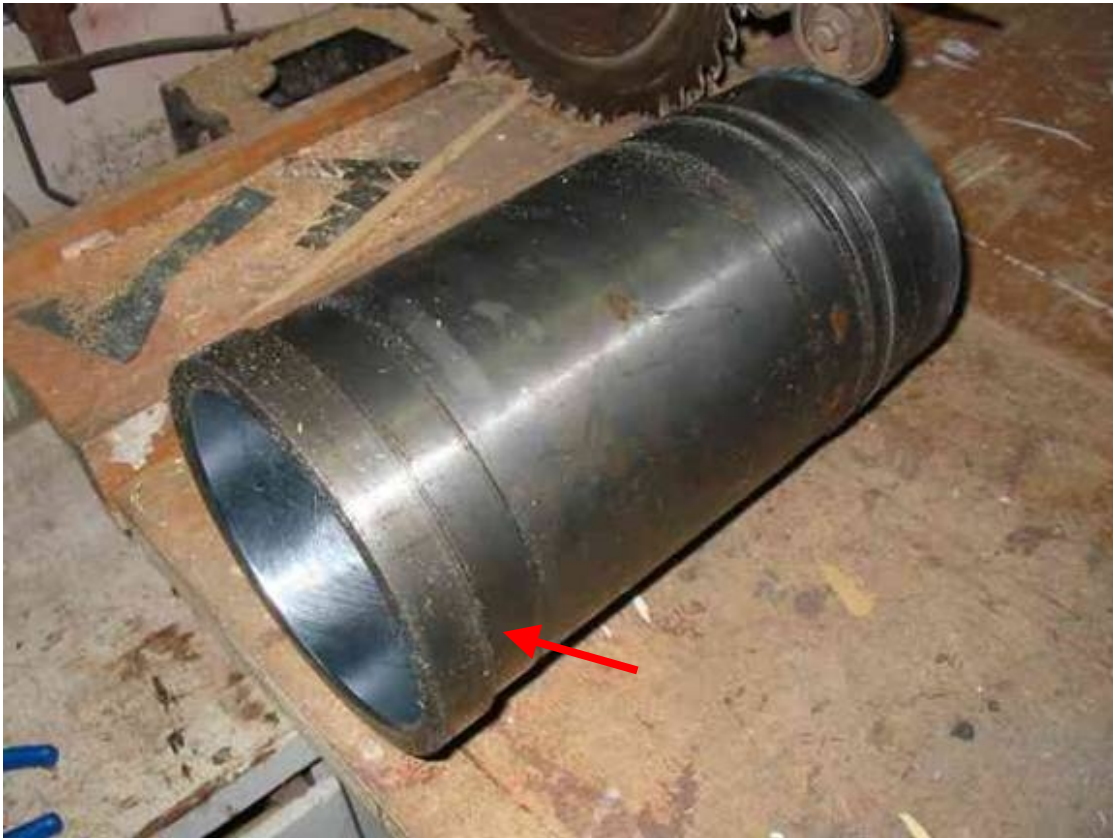
Here are pictures of the sleeve and the cylinder casting just as they appeared at separation.

Note the location of the double grooves near the bottom of the sleeve for the O-rings and the ledge machined near the top of the sleeve. The ledge engages a corresponding

one on the cylinder casting which holds the cylinder liner in place. Rubber o-rings at the base of the liner prevent coolant from contaminating the crankcase.

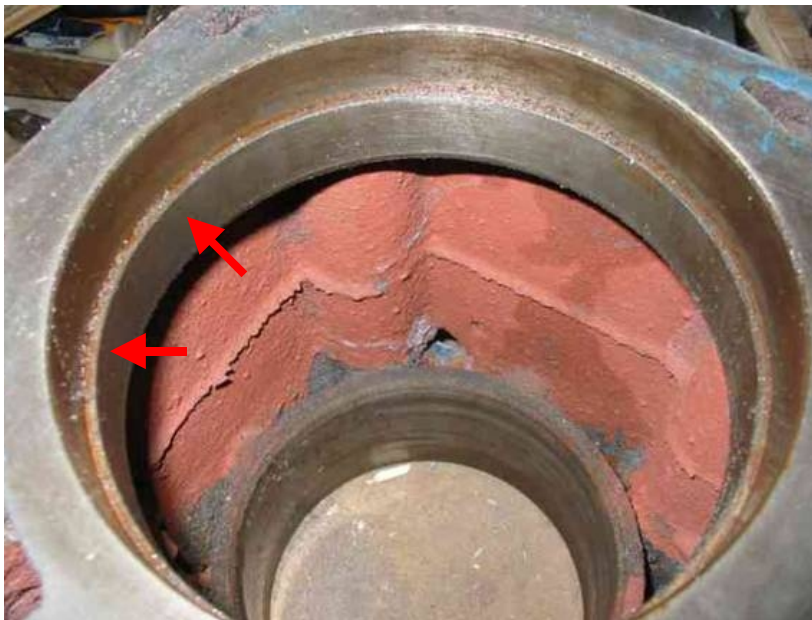
Looking down the bore of the cylinder casting in the picture below you can see a ledge (red arrows) machined into the cylinder casting that engages another ledge (red arrow in picture above) that projects out from the sides of the sleeve. These ledges must be clean (which they're not in the picture) or the cylinder will not be square to the casting

and the lip will project higher above the cylinder casting than it was intended to project. You can see the grit that was left on the ledge, which raised the cylinder sleeve appx. 0.005" above where it sits when the ledges are clean.

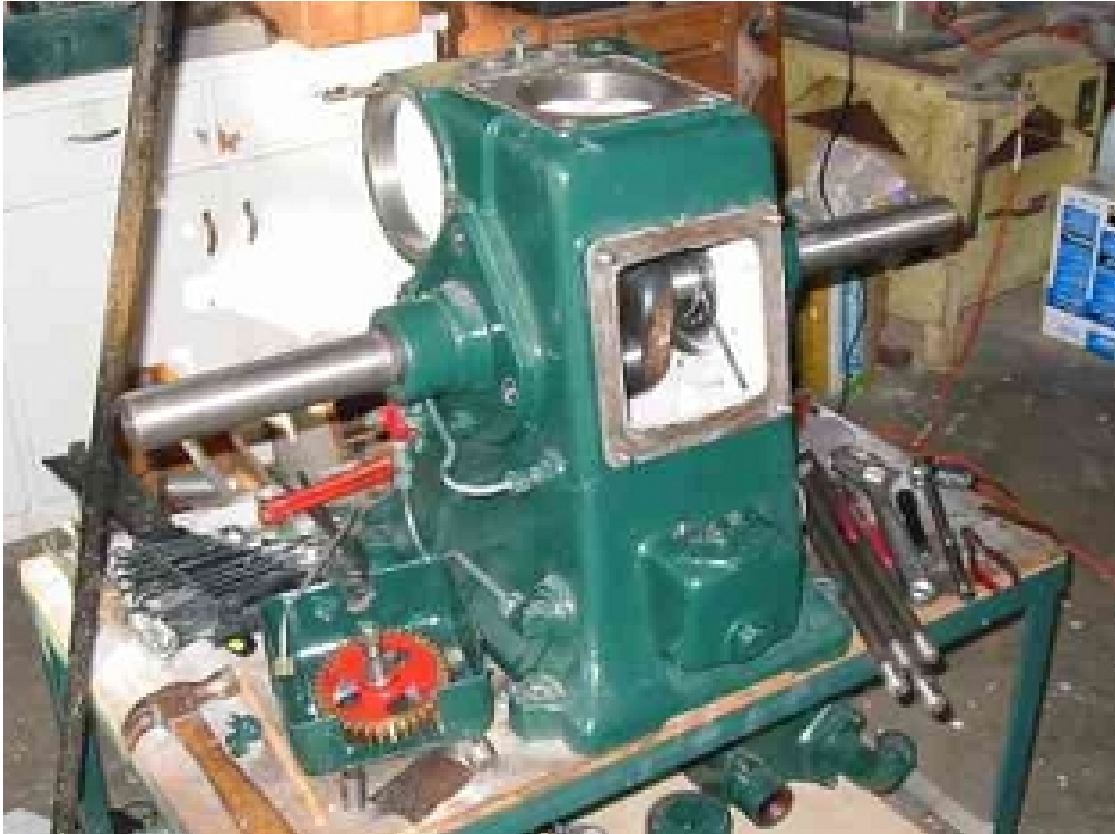
the crankshaft could not be turned by hand without exerting several ft-lbs of force which is a lot stiffer than I would have liked it to have been. It was clear that whoever assembled this engine wasn't very careful to avoid excessively pre-loading the TRBs.

I removed two 0.018" (rust colored) shims from the left side TRB housing and one 0.018" and two (yellow) 0.0075" shims from the right housing. I think there probably should have been about another 0.020" there to get the proper spacing for the bearings, but I'll address that when I'm reassembling the engine. With the TRB housings removed, the crankshaft came out and I set it aside in a safe location with clean rags tied around the crankshaft pin to prevent any damage to its polished surface.

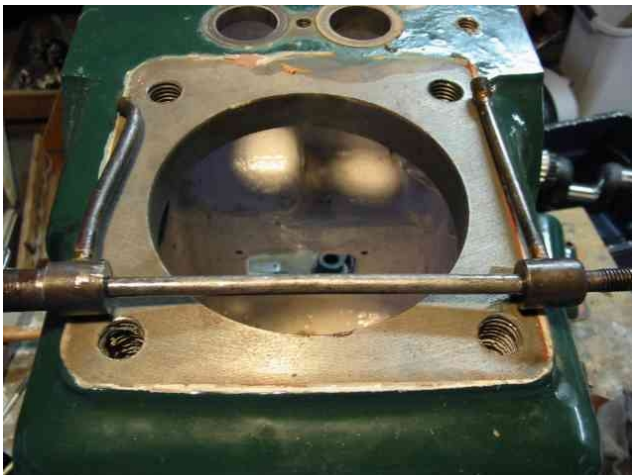
Oil Pump and Lines

I removed the oil pump and oil lines from the crankcase. The oil distribution system has a crossover tube that lies just inside the big crankcase access door. While I was disassembling the engine in preparation to strip the paint, I puzzled for a while at how the crossover tubing could be disconnected. It appeared that there

must be a sleeve fitting somewhere. Otherwise I couldn't see how to remove it. The picture at the bottom of the last page shows the relationship of the components. What appears to be dirty or damaged threads in the lower left stud hole in the picture is actually the remains of a rubbery thread sealer the assembler placed on the threads of the stud during assembly. Since water may find its way into the stud cavity from a weeping cylinder head gasket, it's a good idea to seal the threads when you replace the studs to keep coolant from dripping into the crankcase.

Here's a shortcut taken that nobody is likely to find until they tear an engine apart. Both ends of the crossover tube were ground to a taper but were never soldered. No compression fittings, no tapered seats. One wonders how much oil delivered by the pump leaked out of these fittings. It is fortunate that this engine is splash lubricated and that the oil pump is really not necessary for effective lubrication of the TRBs.

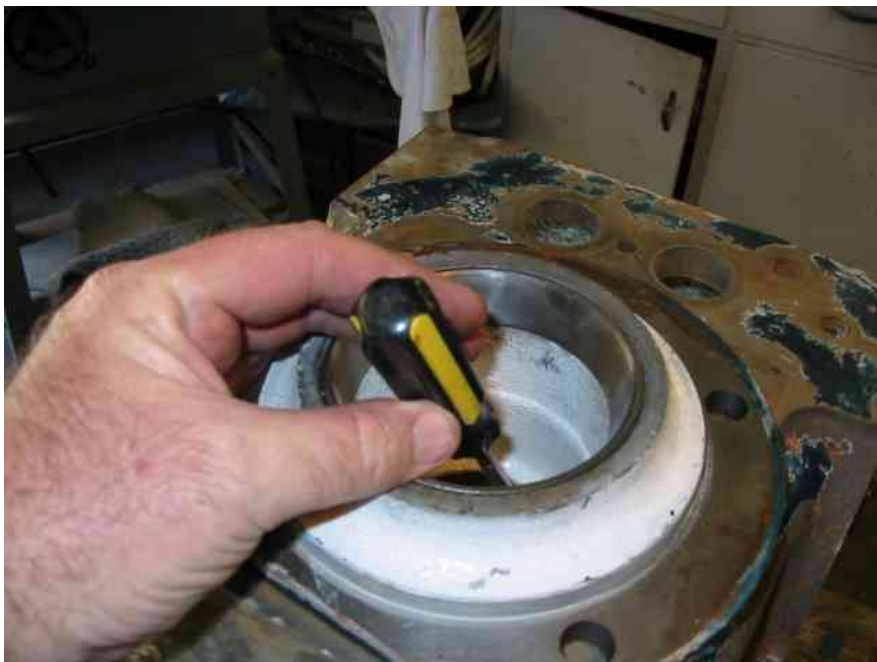
Removal of Oil Seals and TRB Races

Before stripping the paint, I tapped out the TRB races and oil seals using tools I'm not proud of, and which I don't recommend: a screwdriver and a hammer. I know there's a better tool for this, but I don't have one. So I wrapped some cloth around the tip of the screwdriver and tapped gently.

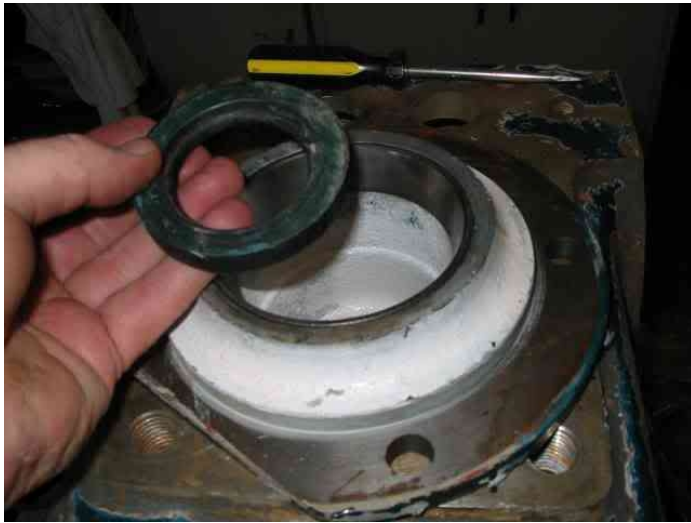
Gentle tapping on the handle of the screwdriver freed the seal without damaging it.

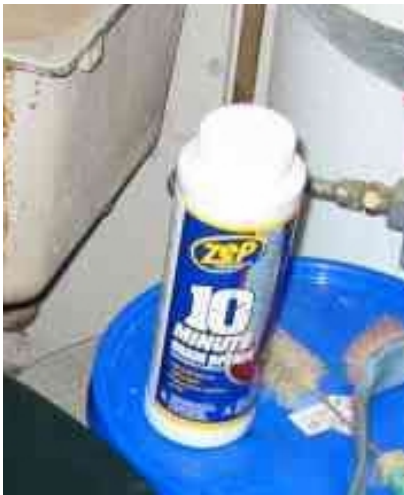
Stripping Paint from Engine Castings

While I was removing small parts from the engine, I experimented with different methods to remove paint, gray primer, plaster filler and some rust-colored filler that seems to be used everywhere on this engine. Common paint stripper is too slow and weak and needs to be applied multiple times in order to remove the tenacious green paint from metal surfaces.

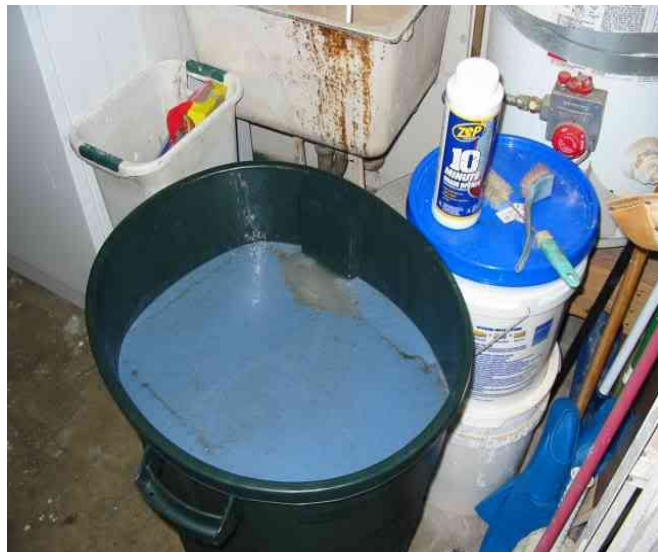
While I was at it, I got inspired (carried away?) and decided I'd hot tank the crankcase, too. So I got a new 34 gallon plastic trash can (my old one has holes in the bottom). I placed a few bricks in the bottom to use as spacers, then with some help I placed the crankcase, stripped of everything removable, inverted in the trash can so the cylinder deck was resting on the bricks. Then I began filling it with hot water and added 1 ½ bottles (3 lbs) of drain cleaner.

The liquid bubbled like a witch's cauldron as the drain cleaner dissolved. Lots of vigorous activity in there. In order to ensure complete mixing I lowered a small plastic submersible fountain pump to the bottom and plugged it in. I thought it might, too, be dissolved by the lye, but after a few hours I pulled it out and it was running, so I left it in the trash can overnight.

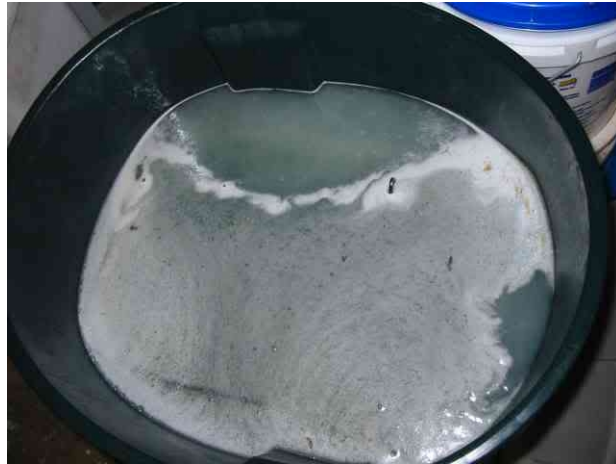
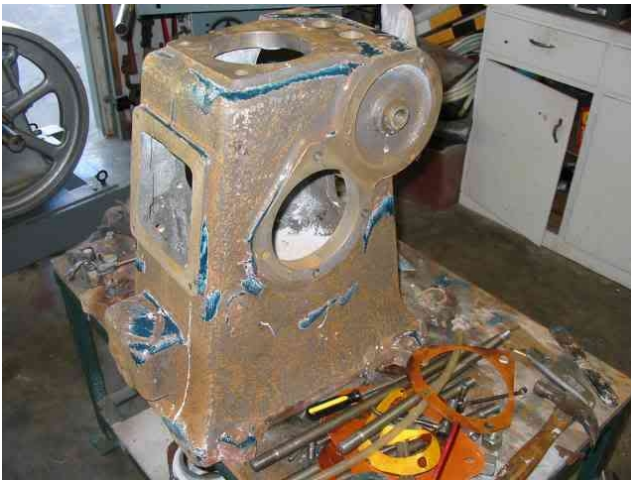
The next morning I lifted the crankcase out of the trash can and hosed it off. You can see in the picture at left that the paint removal was not 100 percent effective after only 8 hours soaking. I was too eager to see results and the concentration of drain cleaner wasn't enough to do the job in the time I allowed. There are still a few places where the paint didn't quite come off. And two areas in the bottom of the crankcase held bubbles of air, keeping the caustic

solution from reaching them, so I'll have to strip them the old fashioned way. Next time I would use two full bottles (4 lbs) of drain cleaner and let the case soak a full 24 hours before removing. No harm is done to the metal by allowing it to soak a little longer.

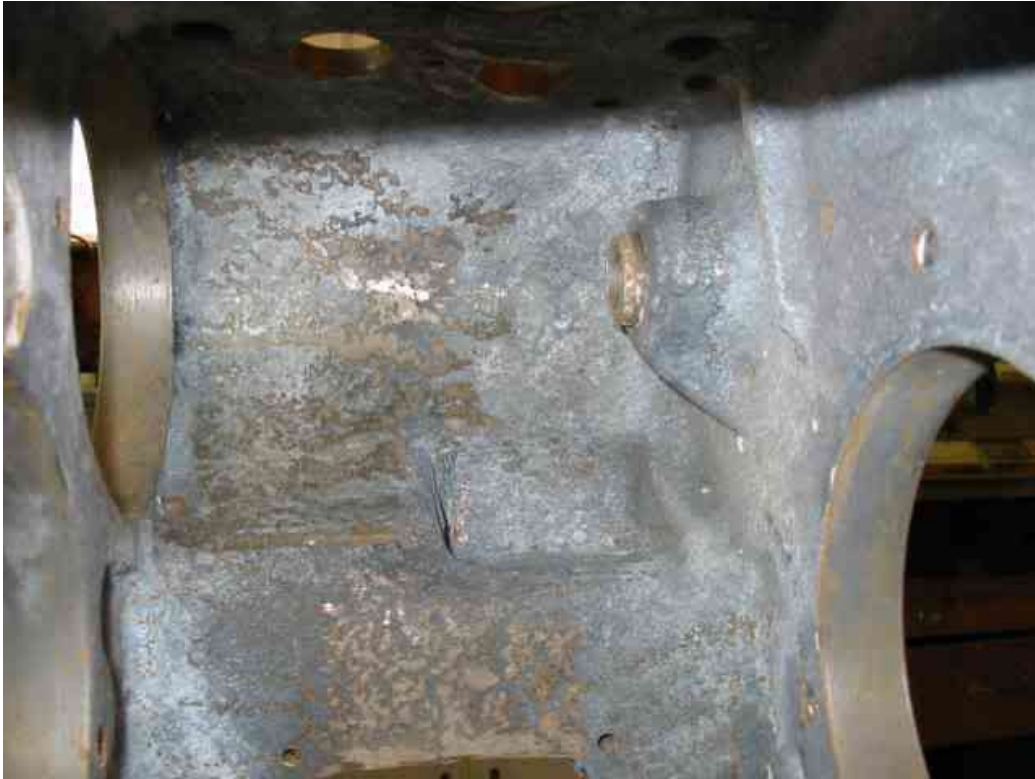
Below is a shot of the inside of the crankcase. That nice smooth white paint that the Indian painter carefully applied is history. The bare casting remains. I poked around and found only one dime-sized area of grit behind the bumpout that holds the cam bushing at upper right of the picture below. Whoever prepared this crankcase did a decent cleaning job before it was painted. There are two reasons for painting the inside of one of these engines. The first is that cast iron is porous and lube oil will weep through the castings eventually. Second, any casting sand that might remain can be

effectively sealed under a layer of paint. Unlike a gasoline engine, diesel engine crankcases are not a hostile environment to oil based enamel paints. There's no reason to use expensive two-part epoxy paints inside a crankcase. I planned to use the rest of the can of red Rustoleum enamel in a quart can that I painted the inside of my Ashwamegh with.

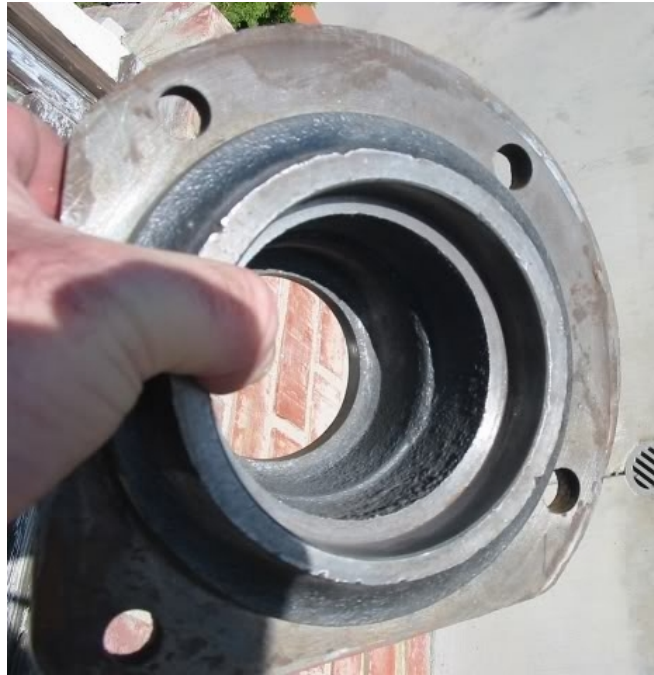
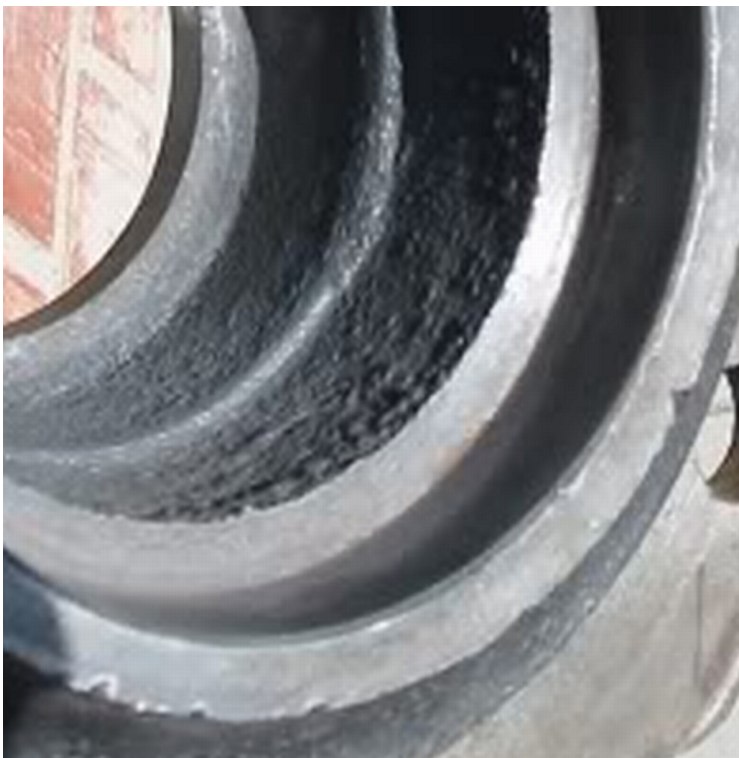
As I was drying the stripped castings and admiring how clean everything was I noticed that the inside of the main bearing carriers were unusually rough. On closer inspection I discovered that the castings were coated with a very thick layer of casting sand. These parts had not been cleaned before they were painted. *And these parts were the parts that held the TRBs.* Not good. But I guess it wouldn't be an Indian Listeroid without some sand.

A close-up photograph shows the gritty surface. The grit was removed in a few minutes by using a wire wheel in the chuck of a portable drill. The surface is now ready for paint.

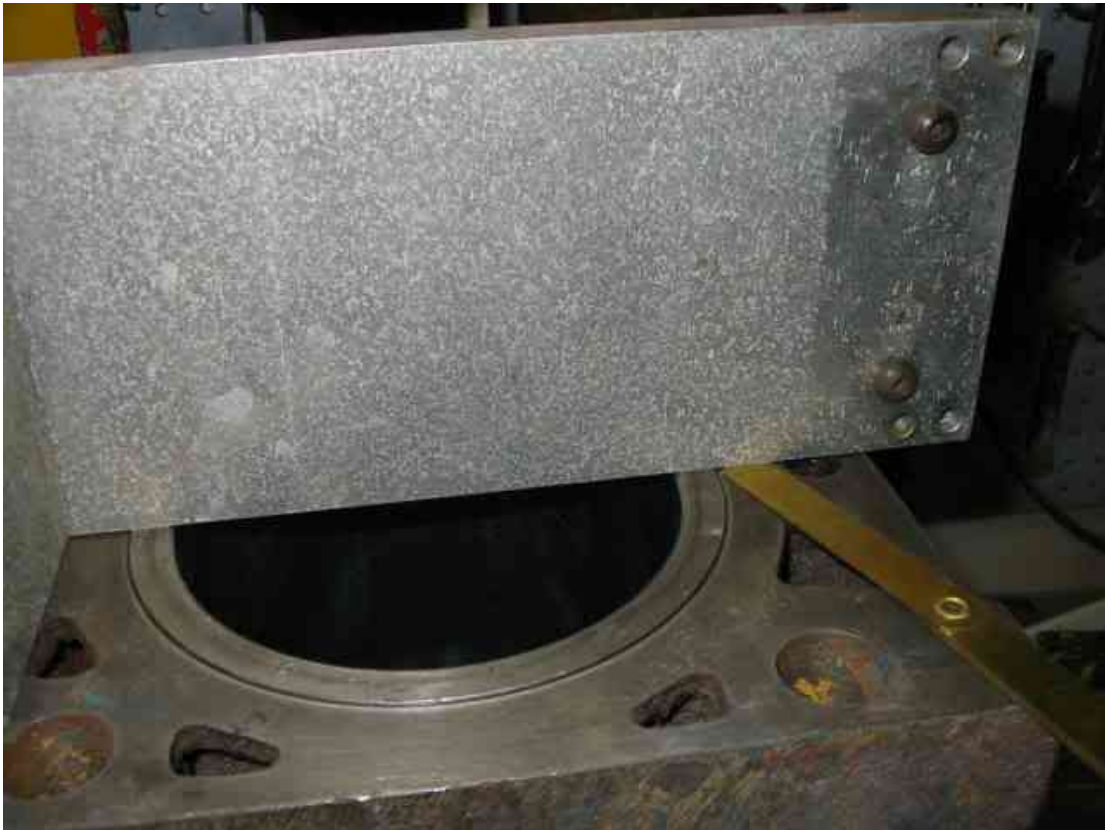
I replaced the cylinder sleeve in the block and set it up on wooden blocks in order to test the squareness of the sleeve to the top of the cylinder casting. I used a piece of ½" aluminum with a machined edge as my straight edge and measured the protrusion of the cylinder sleeve above the casting in four places using brass feeler gauges.

This measurement reveals two things. First, it indicates how square the sleeve is to the cylinder casting. Second, it will also indicate where there is excessive protrusion of the sleeve over the cylinder casting.

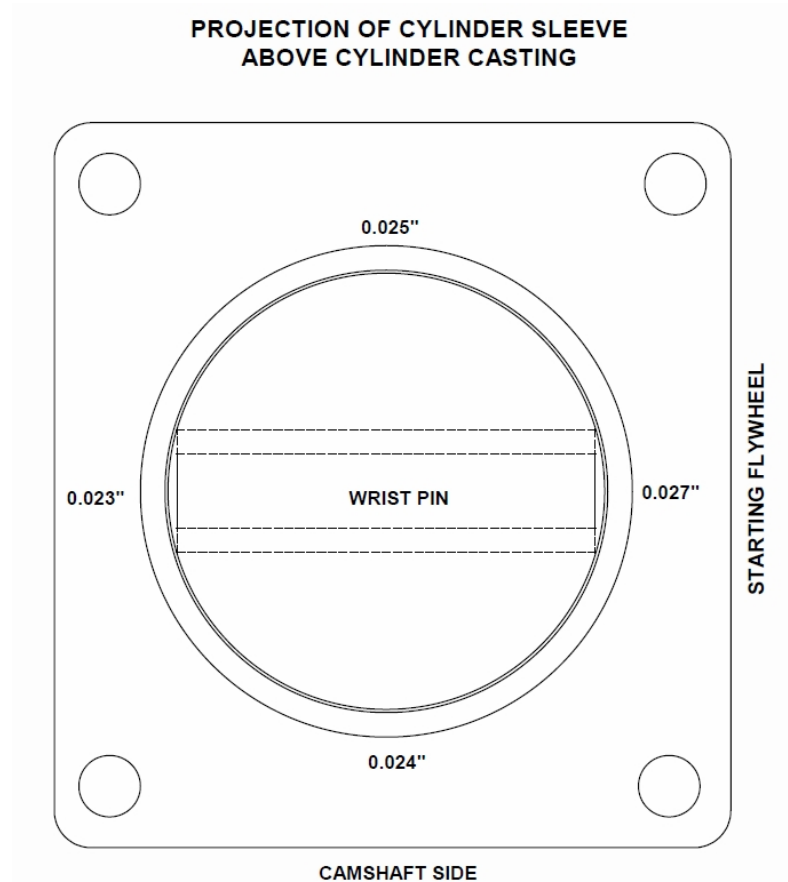
Results, displayed on the drawing at right, indicated that there was 0.001" difference between the front and back measurement (I call "front" the side where the camshaft is), and 0.004" along the axis of the wrist pin.

So how far out of level is the top of the cylinder liner? We can disregard the 0.001" front and back. How 'bout 0.004" along the axis of the crankshaft? I think that's worth machining off.

flywheel side, recall that the squish area was measured on both ends of the wrist pin as 0.065" Without the 0.0075" gasket on the flywheel side, that measurement would have been 0.0575 on that side of the piston. The shims were used to make the bottom of the cylinder head parallel to the piston top surface.
