Inspection and Assembly of a Power Solutions 6-1 Lister-Type Diesel Kit Engine, Part I

The Beta Test Engine

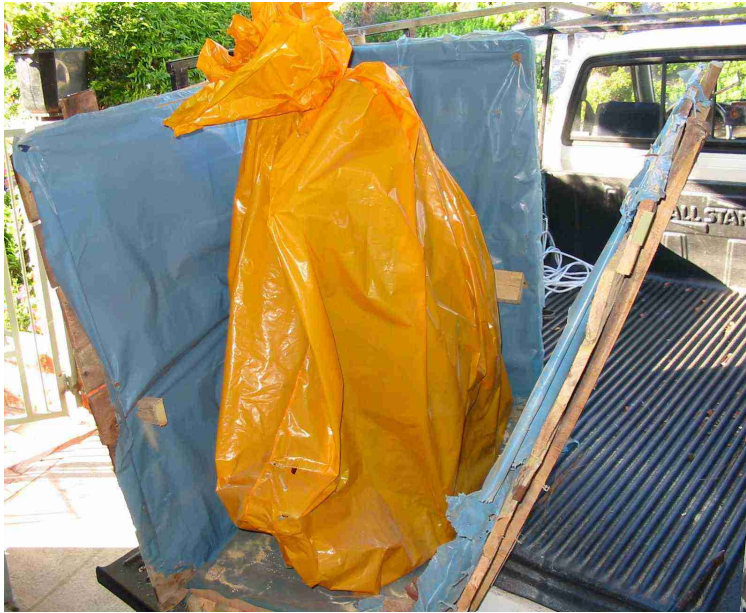
The components and crankcase/cylinder subassembly arrived at the ABF freight yard in separate wooden crates which had been strapped together with the spare parts kit on a 4' x 4' wooden pallet for transport. The straps holding the heavy components to the pallet passed over the spares kit, which were packaged in chipboard outer cartons with Styrofoam liners. A careless forklift handler could have torqued the package enough to crush the gas tank contained in one of the chipboard boxes. Since they are lightweight, I wonder if it would be worthwhile to ship them separately.

The forklift driver at the ABF Freight dock kept commenting about how heavy such a small crate was. I told him it contained diesel engine parts and that seemed to make sense to him. I tied the load in place to the lumber rack on my pickup with every sailor knot I knew, but as I drove home the crates slid around on the slippery bed liner, so I took corners carefully. It seemed no matter how I lash stuff down, heavy items slide on the plastic bed liner. However, that makes getting the crate out the back onto the tailgate that much easier.

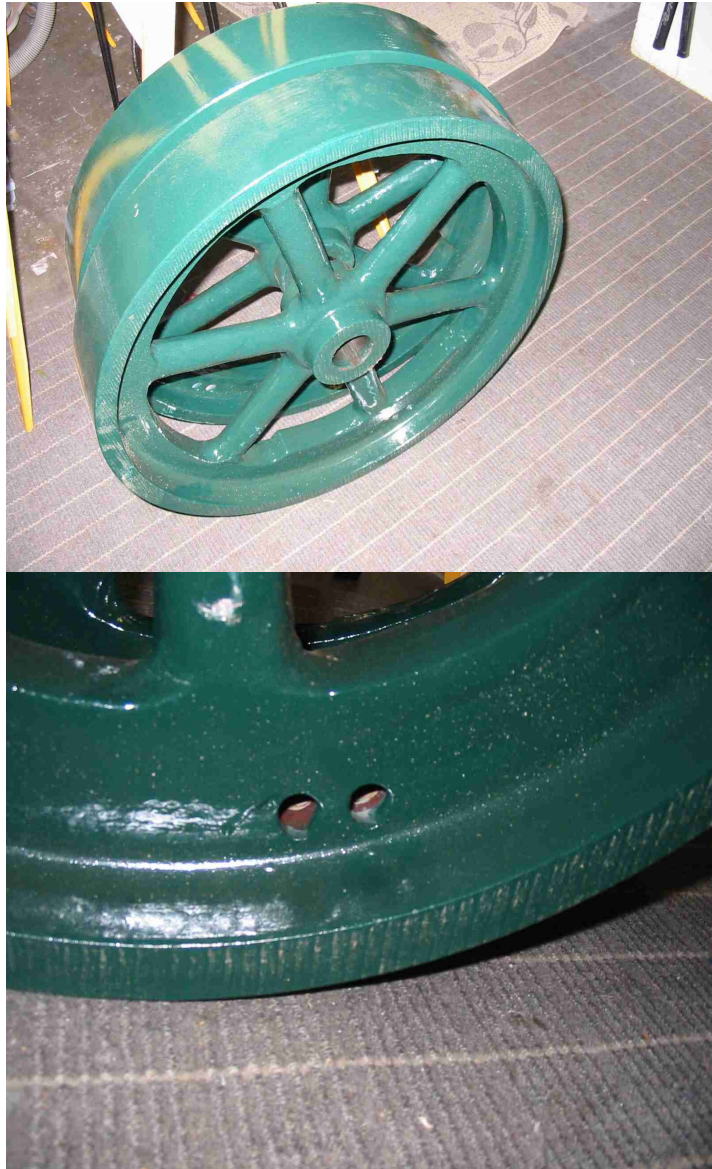
The flywheels each have two drilled holes 5/8" diameter in the web, indicating that they may have been balanced. The holes were drilled in different locations on the web of each flywheel.

Unlike the flywheels on my Ashwamegh 6/1, these flywheels were drilled in the web supporting the rim, and not into the rim itself. Drilling the web to be preferred because the rim of the flywheel is already under considerable tension which was induced while the rough casting cooled. Tension is increased further while turning at speed. Any removal of metal from the rim weakens the flywheel and invites failure. There are enough surprises in Indian castings without making more of them. If metal must be removed to achieve balance, and I don't believe that should be done, it should be removed from the web and not from the rim. A flywheel can more easily be balanced by adding lead weights to the rim without removing metal and weakening it.

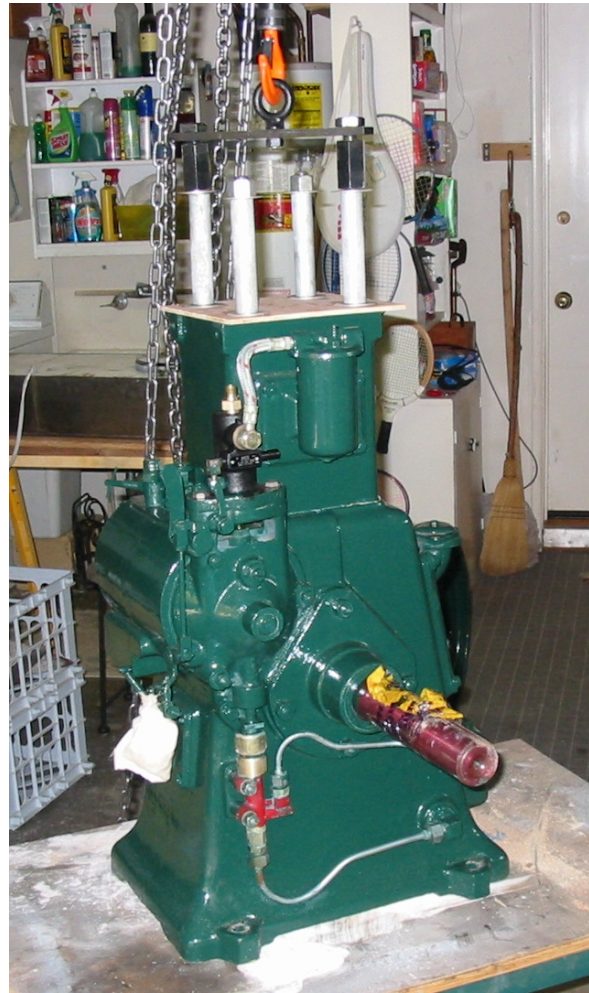
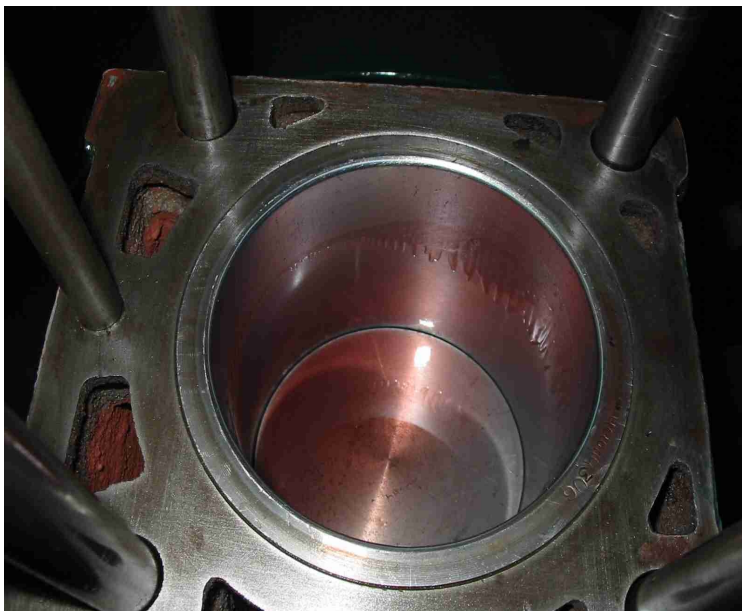
I removed the cylinder cover and peered into the bore. The temporary aluminum gasket and plywood backing kept the cylinder very clean, and thick red oil covered the top of the piston, so whoever did the assembly did it right. No dirt, no rust, plenty of lubrication. The cylinder bore was nicely machined and honed with hone marks crossing at 90 degrees in the middle of the stroke, as they should. A wipe with a white cloth indicated no residue from the honing operation.

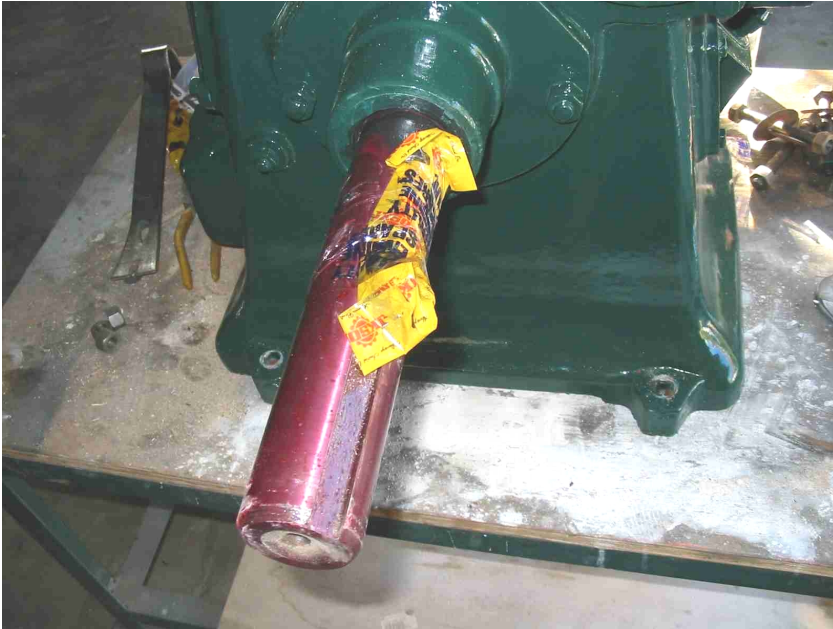
While waiting for the cylinder head, which had shipped separately, to arrive, I decided I would do some basic inspection and mount the flywheels on the crankshaft. First I had to clean the red anti-rust compound off the crankshaft ends.

Acetone applied with a natural bristle paintbrush melted the red compound immediately but didn't affect the green paint. I was careful to keep the acetone away from the crankshaft oil seals.

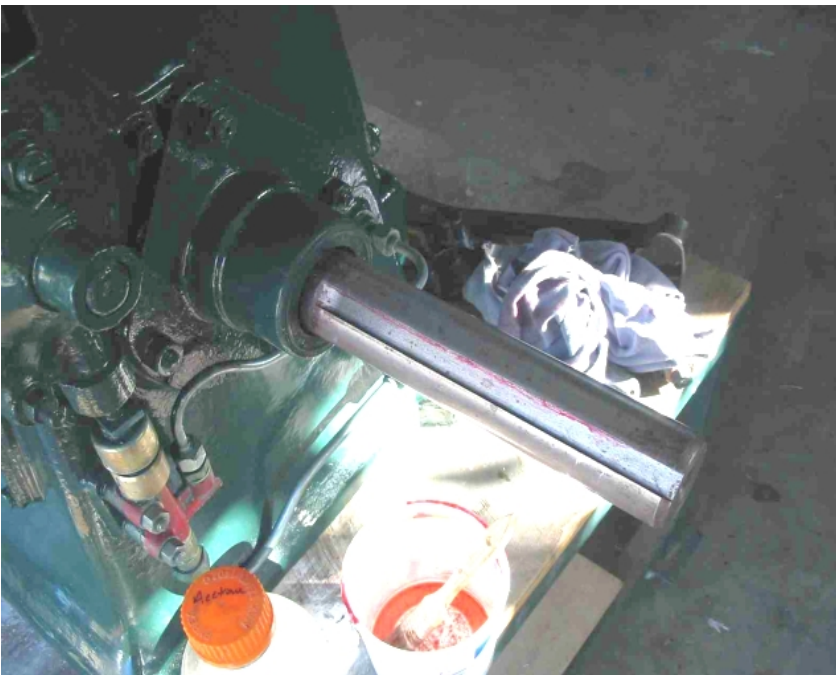
The flywheels slid on without a hitch. The gib keys fit as tight in the keyways as last summer's swimsuit. I had to insert the keys in the outboard end of the crankshaft keyway and tap them lightly with a hammer to move them along toward the flywheel hub.

My other engine had a cumulative total of 0.029" clearance between the crankshaft keyway and the gib keys and the flywheel keyway which was causing the engine to sound like it had rod-knock. Brass shims applied between the sides of the key and the keyway in both the shaft and the flywheel fixed that problem, and that engine now runs like a watch.

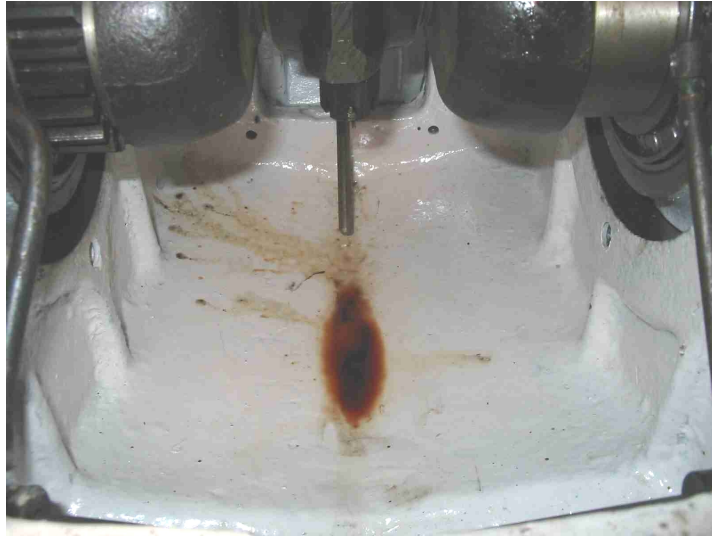
I pulled the crankcase access cover and took a close look inside. Whoever painted this crankcase took his time and did a nice job. An even thick coat of white paint coated all the right surfaces and didn't coat the wrong ones. Some red assembly oil appears to have leaked through the rings and dribbled on to the floor of the sump. A few chips of paint that fell off the tappet guides as they were being removed can be seen on the left side of the sump. Other than that, the sump was clean.

No grit, no dirt, no metal particles, but of course this engine hasn't been run yet. At least this shows that the guy who assembled the engine had clean hands.

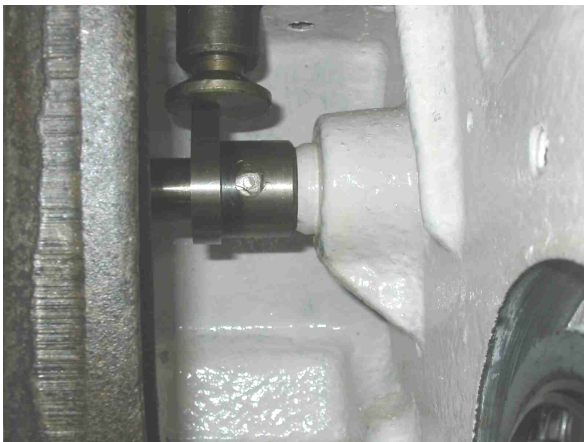
The cam lobes are located correctly to ensure tappet rotation. Note that the painter was careful to wipe paint from the machined surface above the TRB carrier at lower right. Note the tapered pin which holds the cam lobe on to the camshaft has been peened (sigh). If the hole was drilled correctly and assembled dry, the pin should hold without being peened as if it were a rivet.

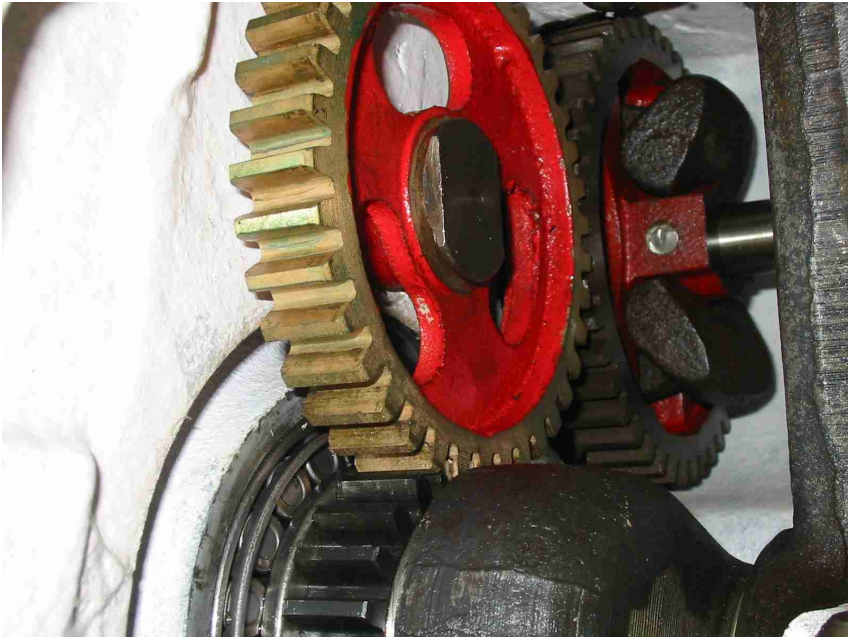
This engine came with a bronze idler gear, thanks to the time and money that Joel Koch spent with a U.S. gear manufacturer in order to determine the best material and tooth profile to specify for the gear. I wiggled it back and forth, but could not discern excessive backlash. But once the tappets are re-installed and the valve train loads the cam lobes that may change. Many (most?) of these engines appear to have a problem with the location of the idler gear shaft, causing excessive gear train backlash and ultimately broken timing gears.

Unlike my other Indian engine, this one has the “kangaroo pouch” upper/lower sump arrangement like the original British engines had. It should provide enough isolation from the goings-on upstairs to allow large particles to settle. More so if one uses non-detergent oil such as is still used by

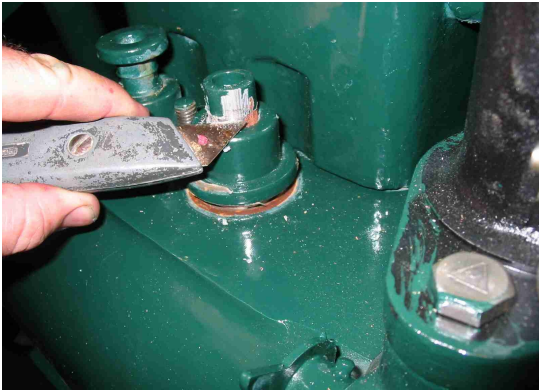
Removing the Tappet Guides

The tappets and guides were pretty well glued together with paint. I could have gotten them free by just oiling them and scraping a little paint away with a knife, but since I was waiting for more parts to arrive, I thought I'd pull them and do a more thorough inspection and cleaning.

I pried the tappet guides free of the deck with a set of round jaw Vise-Grips. Just a slight twist and the paint seal broke and the guides came free of the deck. I didn't squeeze too hard, so didn't scar the flanges. If you're squeamish about using

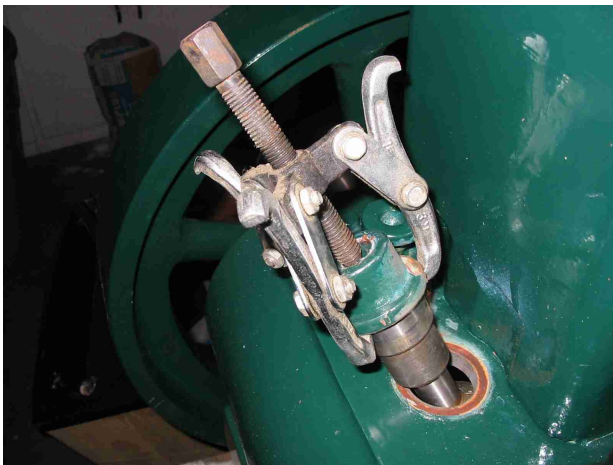
I scraped the paint off the lifter stems, which revealed some minor surface rust beneath the paint that made removing the tappet guide from the lifter difficult. A touch with a ScotchBrite pad will fix that. If one didn't feel the need to do all this, it's a simple matter to just scrape away the paint from the tappet stems to ensure that the lifters rotate properly.

I ended up using a small 3-jaw gear puller to pull the intake guide past a rough spot of rust on the lifter stem. The lifters were then removed from inside the crankcase.

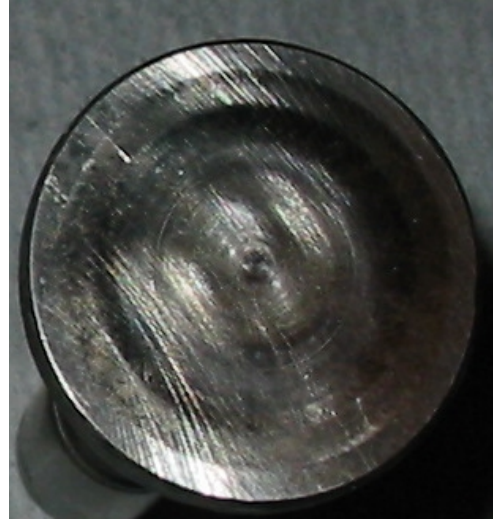
The heat treated lifter faces are flat or slightly concave with concentric machining marks. After I took my first swipe at the face with the paper I noticed three small punch marks near the center of each lifter. The marks indicate that they had been tested for surface hardness following heat treatment. That's encouraging evidence of quality control in Rajkot.

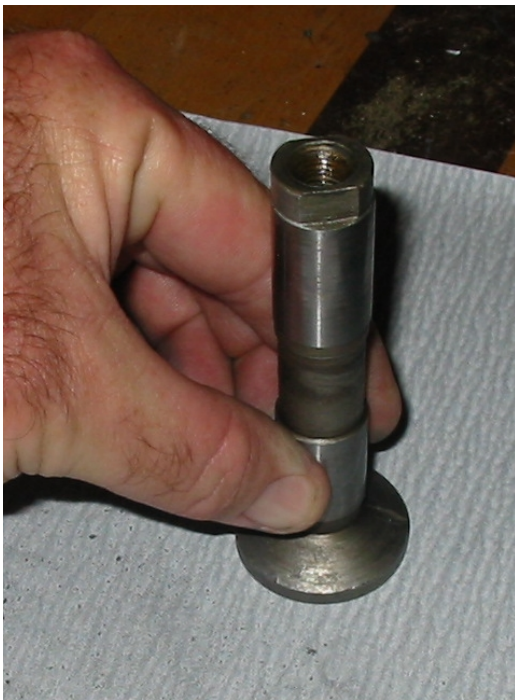
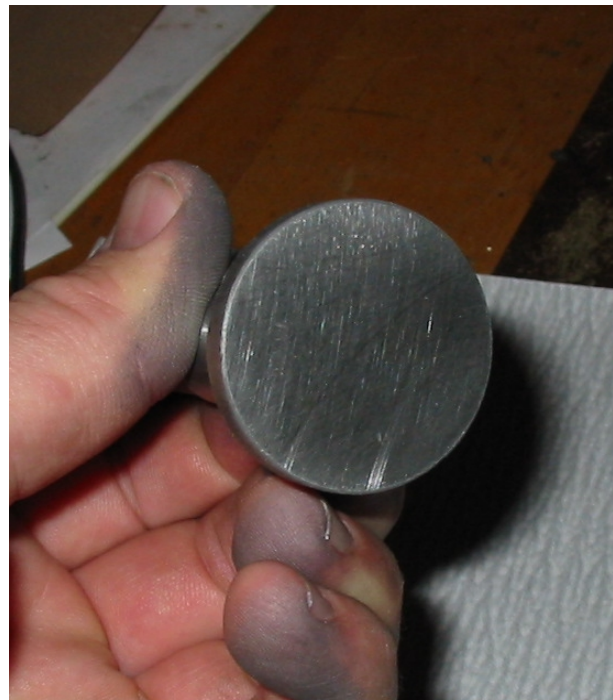
The cutter used to face the lifters appears to have been sharp. I saw no compelling reason to polish the surfaces further to a mirror finish, though I decided I'd lightly face them with 220 grit paper on a flat plate, then smooth the sanding marks on a buffing wheel with rouge.

My other engine had lifters that were cut the same way, and George wrote about seeing that, too. I suppose they are all made by the same manufacturer. Whether the slight concave face was deliberate or the result of their being faced on a worn lathe by a machinist in a hurry to finish the part is difficult to say. The concavity is very slight and likely would have little or no effect on the operation of the lifter.

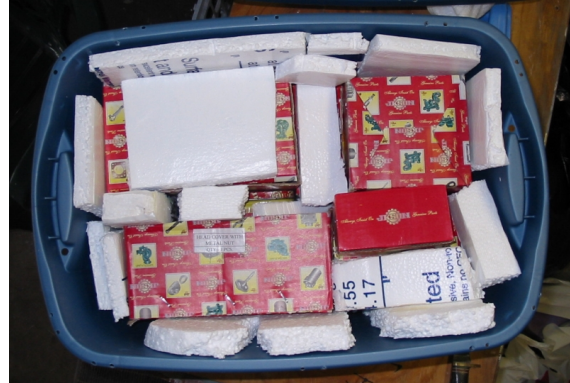
- 1 old-fashioned pump-type steel oil can
- 1 set rod bearings and shims
- 1 set intake and exhaust valves
- 1 pair gib keys
- 1 pair steel flywheel hub covers
- 1 pair pre-formed high-pressure steel fuel lines with ferrules

The last item is a vast improvement over the chromed steel fuel lines that came with my Ashwamegh. The ferrules were nicely machined and silver soldered onto the steel lines. The ferrules on the Ashwamegh were roughly finished by hand on a grinding wheel, leaving facets which caused the connection to leak like a newborn until I touched up the surfaces.

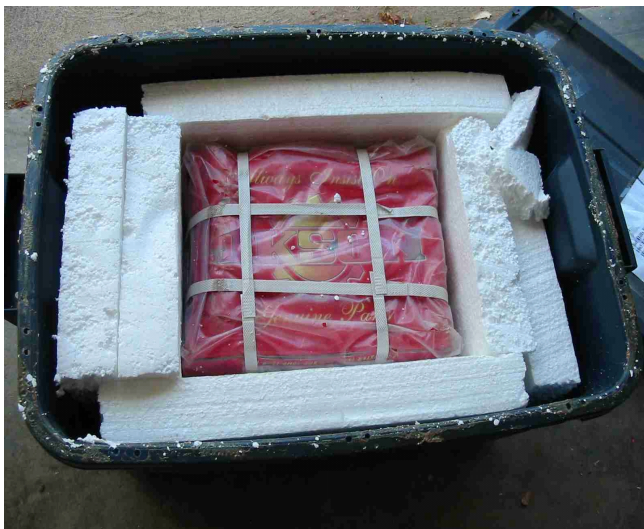
The head was packed securely and the Styrofoam did its job keeping the heavy head from destroying the plastic shipping box.

Contents of the head assembly. Someone in India placed the Power Solutions nameplate in a plastic bag with the mounting rivets dropped in loose. Then the sealed bag was placed on the bottom of the box, then the head was placed on top of the bag. The loose rivets did a good job of mangling the nameplate and registered every bump in the road

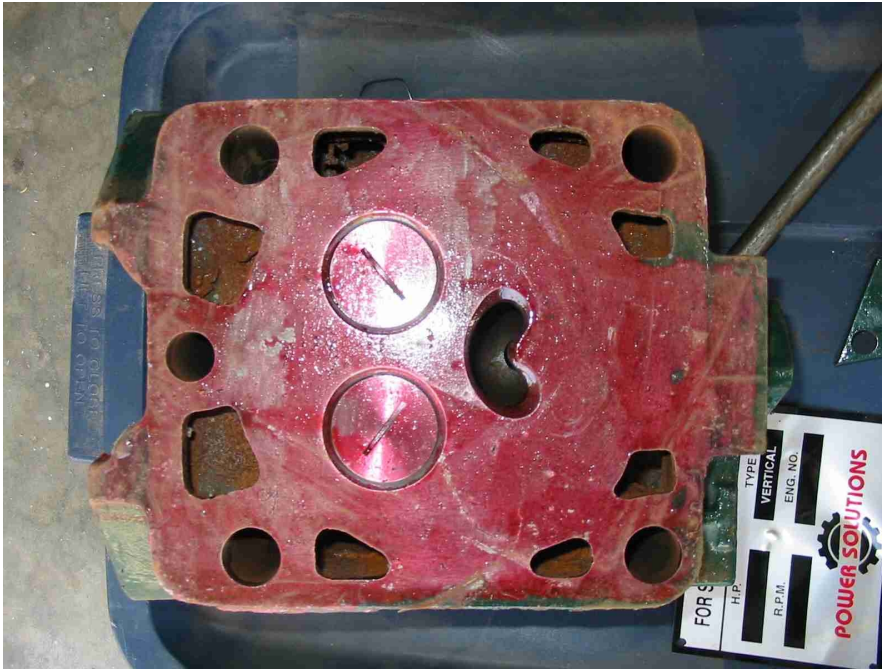
Once the anti-rust coating had been wiped off it was clear that the head had been nicely surfaced. The camera flash makes the surface dirt and rust in the water galleries appear much worse than it did visually.

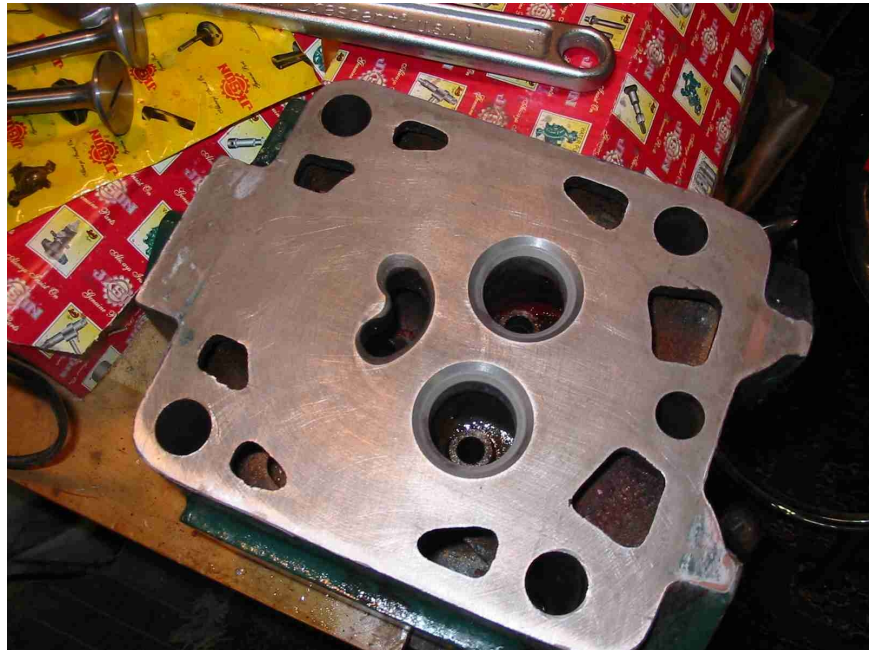
The valves were beautifully machined. They were fully the equivalent of anything you'd find in the West (who, perhaps, source their valves from India, just like they do their piston rings). They fit their guides and seated tightly. Close examination of the valves and their seats indicated that they had been lapped.

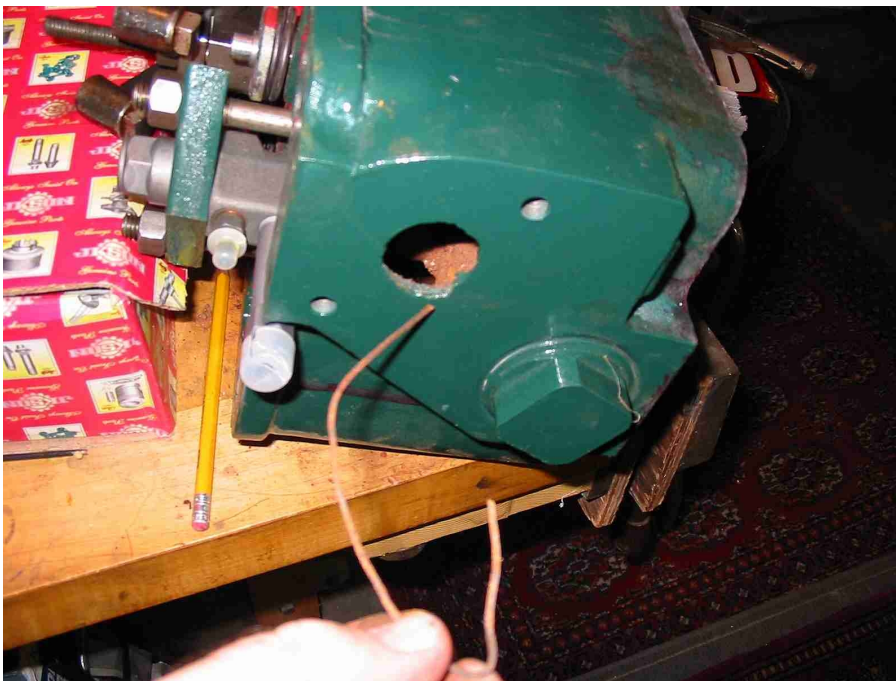
I replaced the valves, valve springs and keepers and installed the fuel injector. Again I have to say that the hardware that came with these parts was far superior to that on the Ashwamegh. Nuts, bolts and studs are thoroughly the equivalent of anything you'd find on an engine built in the West. And, yes, those are my bare size 13s. It's the middle of summer and I kept telling myself that I'd stop assembling after the next part and put some shoes on, but I was having too much fun.

The water galleries in the head were free of casting flash and core sand, however I managed to remove a piece of bailing wire from the water outlet. The wire had probably been used to suspend the head casting from a hanger while it was being painted.

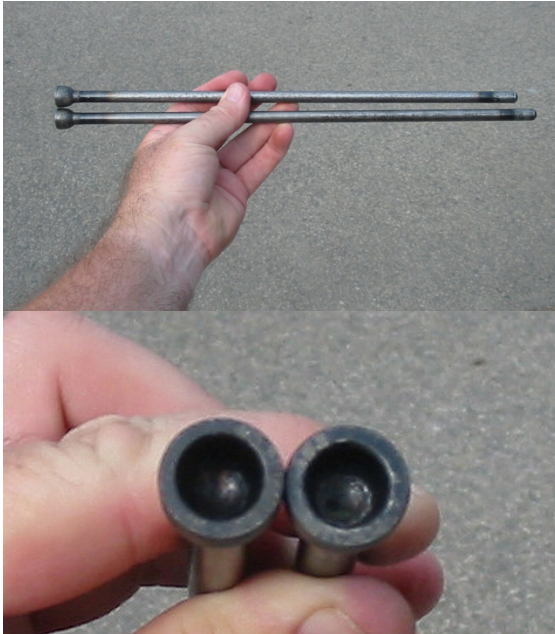
The pushrods were unpacked and cleaned of grease. The fact that both ends are hardened is evidenced by the discoloration that is visible at each end. The rods on the Ashwamegh were chrome plated. These rods will need to be painted before they begin to rust.

Within the cups on the end of the pushrods is frequently found a protruding point of metal, an artifact from the manufacture of the pushrods. These pushrods have no such protrusion which is fortunate since it would have had to be ground off with a carbide burr.

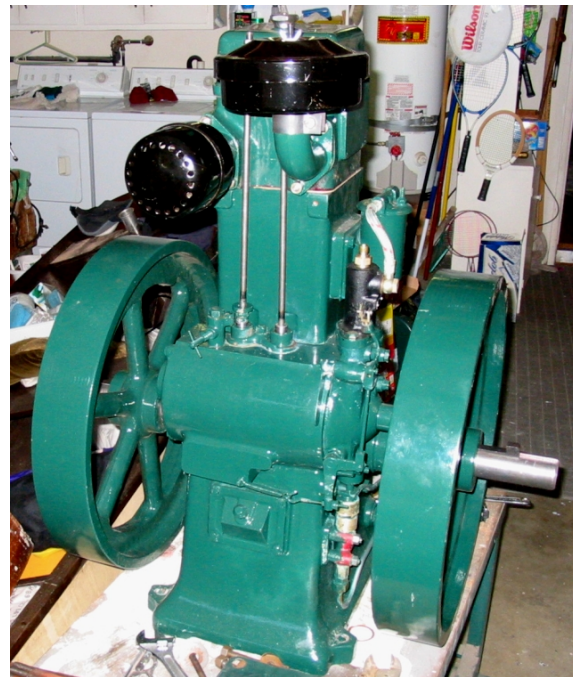
The pushrods were installed, then the flywheels, pepper-can muffler and air cleaner. The gib keys need to be fitted in order for them to more fully engage the flywheel and the keyway in the crankshaft. Presently, they leave about 1" of key protruding past the hub, which is too much.

Although the pepper can muffler won't be used on this engine, except at First Smoke, it was nice to see that this muffler was heavier and better made than the silencer that Ashwamegh supplied.

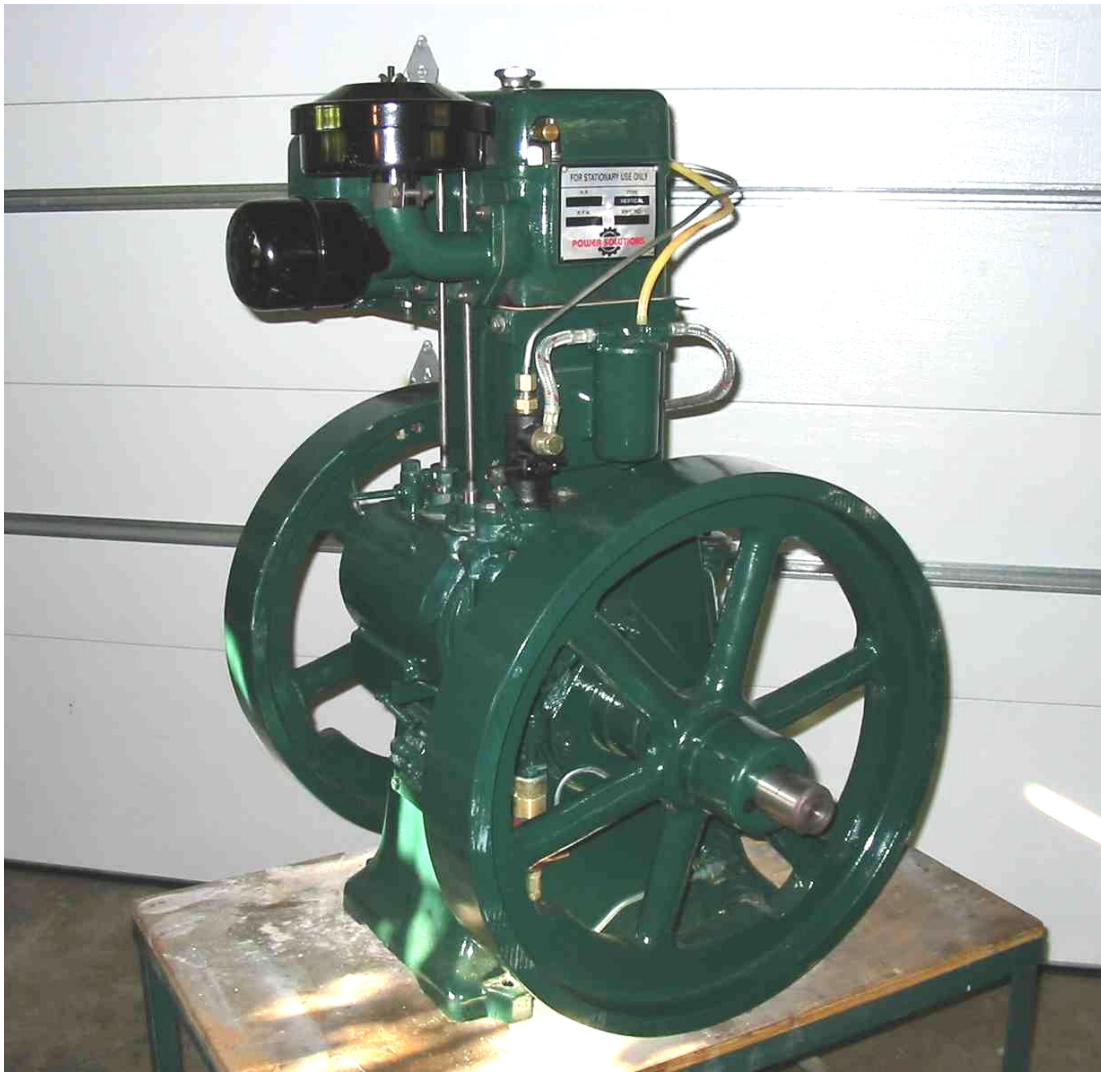
Well, here it is. The engine is ready to start. I found no evidence of casting sand, metal particles or even dirty fingerprints.
